# FM Global Risk Report

### City of Memphis, Tennessee, The County of Shelby, Tennessee, Tennessee Hoops LLP

#### **All in One Interim Risk Evaluation**

Visit by: David Kiser  
Visit date: 16 July 2009  
Conference with: Mr. Bob Tiedemann, Director of Engineering

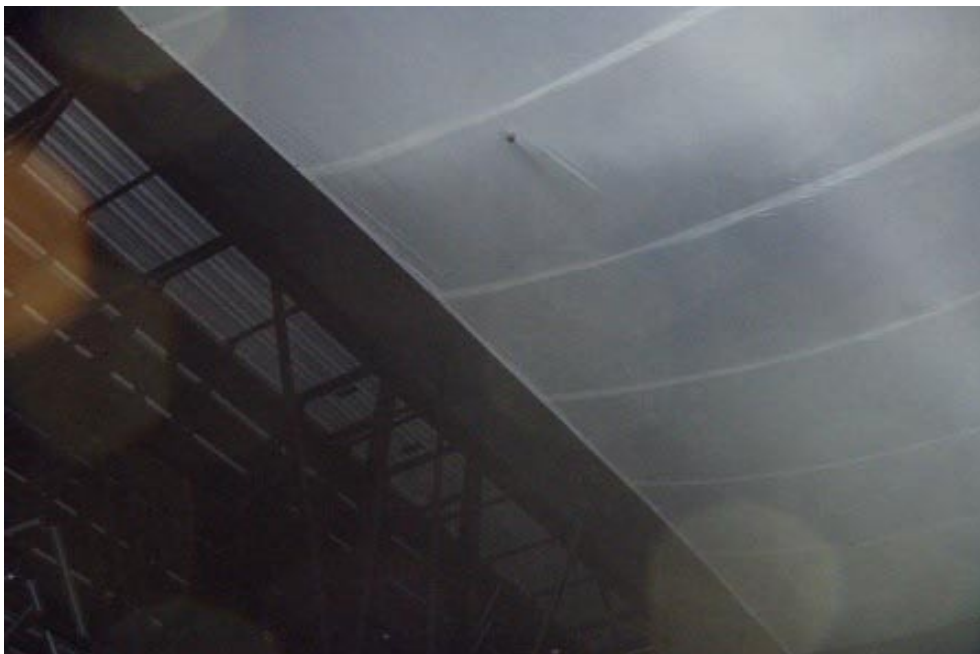
A canvas ceiling has been installed in a hallway for better video projection. Sprinklers were installed to penetrate beneath this canvas ceiling in this approximate 30 x 40 ft. area.

**Canvas Ceiling Installed**
